Strategic Path Review

The ASCENT Site

T1.1

Research on the Impact of Unregulated Access to Upland Sites

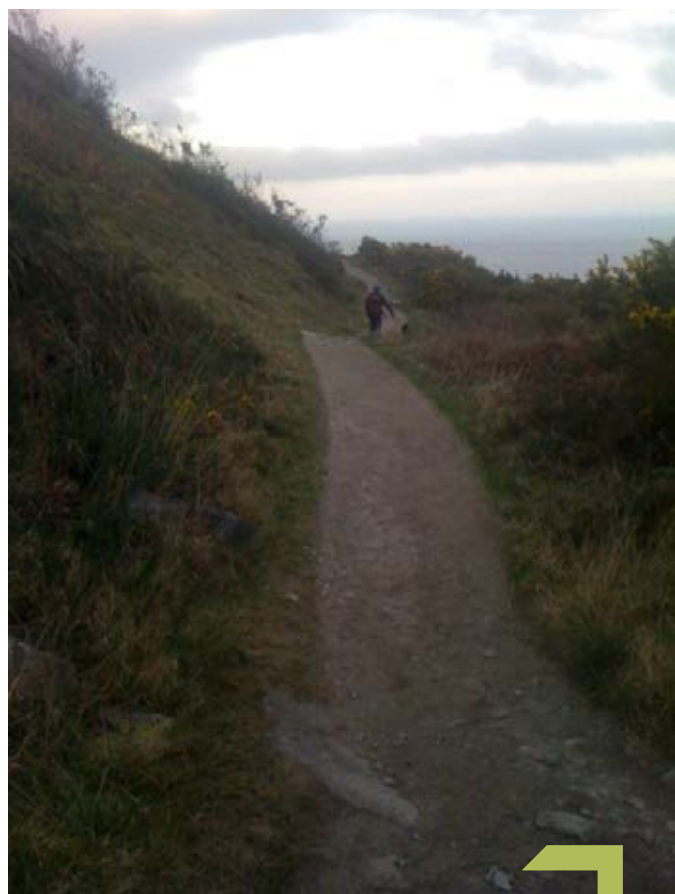
SECTION 1A

This picture shows the nature of this path near its start – note the width and very even compacted surface.

Length	1,200m
Counter data	---
Path surface	Stone pitching, exposed bedrock, compacted earth, mud and gravel
Width	1m – 2m
Evidence of erosion	Some evidence of erosion at isolated locations, includes some gullying and wash out
Braiding	Heavy vegetation, including gorse and bracken, prevent extensive braiding though there is some in isolated areas
Evidence of path repair	Extensive stone pitching which has been largely successful. Some minor works above pipeline.
Associated features	Footbridge over Glen Fofanny River
Trail Classification /Grading	Category 5 (due to width, steep exposed bedrock section, large level changes and uneven surfaces)
General Observations and Recommendations	<p>This section is very heavily used by outdoor centre groups accessing the adjacent gorge. This is leading to the development of numerous desire lines at key locations which are having a significant visual impact. The remainder of this path is in a relatively good condition though minor erosion and braiding should be addressed by effective trail demarcation.</p> <p>It is important to address the desire lines caused by gorge walking groups since these have the potential to become damaging to sensitive habitats, particularly around the banks of the river. This could be achieved by developing agreed access and egress points and developing robust paths at these locations.</p>

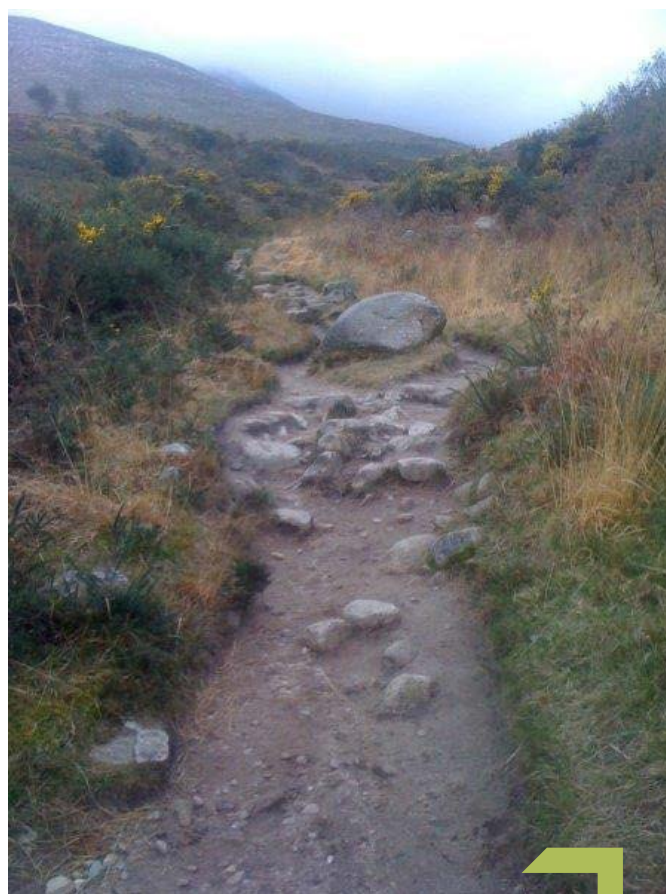
This picture shows a section which is typical of this path – note how the vegetation is effectively demarcating the path – also note the slightly uneven surface.

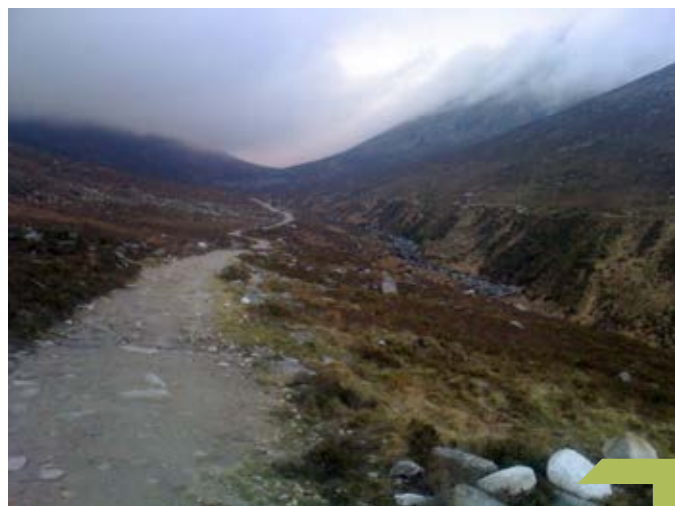
SECTION 1

This picture shows Section 1 looking uphill towards the quarry - note the width of the track and the compacted and even surface. The path is somewhat visually intrusive in terms of its width and the pale colour of the surface, but this may reduce over time and weathering.

Associated features	None
Trail Classification /Grading	Category 3
General Observations and Recommendations	This once heavily engineered and well maintained track had become derelict and users, including vehicles (farmers, NIFRS etc.) and walkers, were increasingly using adjacent land causing impact on the SAC and farmed landscape. The track itself is somewhat visually intrusive, but recent work has attempted to utilise sustainable techniques. It is a very important alternative to the path on the other side of the river (Section 1b), which is becoming increasingly eroded. It is essential that unauthorised vehicles are excluded from this section, since this could lead to greater impact on the surrounding area. The landowners worked with MHT/NT/NIEA to manage this site.

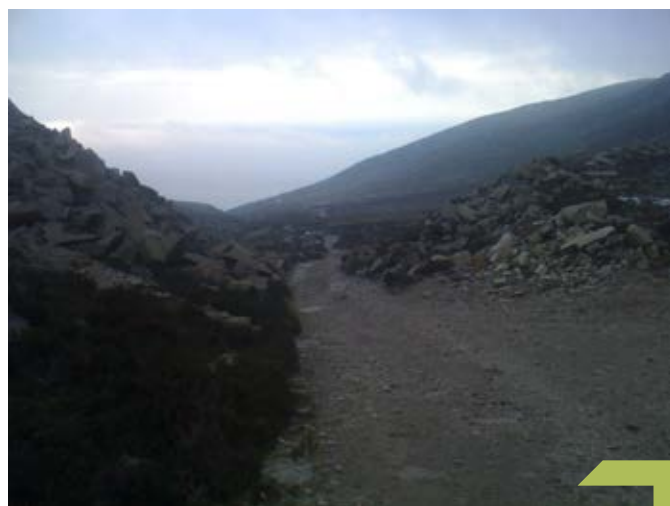
This picture shows the path looking east down from the Crannoge Quarry itself. As indicated above the path was established to access this quarry and has in the past been surfaced with bitmac & concrete in places. Damage to the surface of the track, a lack of maintenance and pressure to reduce impact on the surrounding land and to sustain vehicular access led to key upgrading works. Anecdotal evidence is that more people are keeping to this track than before the works.

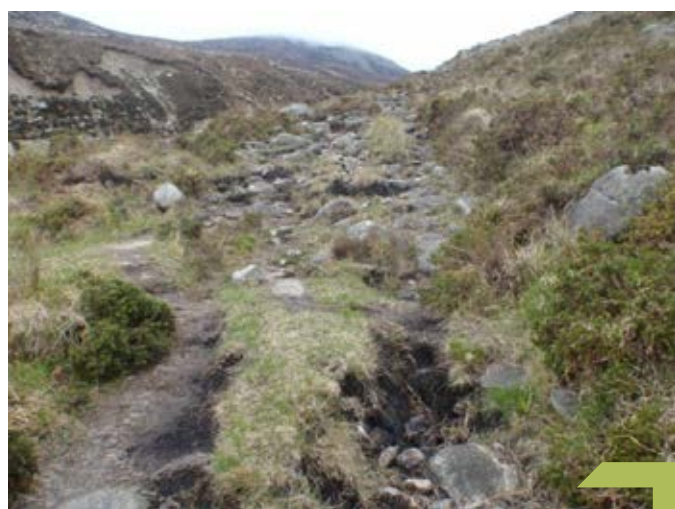
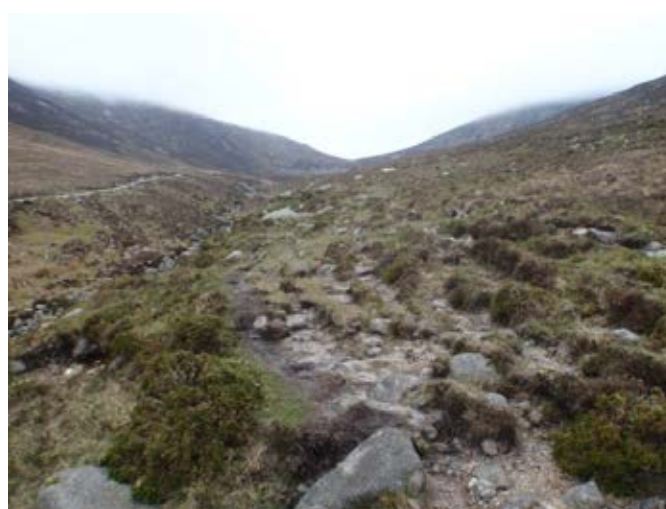
SECTION 1B

These pictures show some of the erosion on the path on the north side of Bloody Bridge River

Width	1m – 5m
Evidence of erosion	Very extensive erosion, particularly at the start where slopes are steepest. There is some potential for slopes to become unstable.
Braiding	Very extensive braiding throughout with no single clearly defined line. Extensive impact on surrounding vegetation.
Evidence of path repair	None
Associated features	None
Trail Classification /Grading	Category 6
General Observations and Recommendations	This section is quite heavily eroded in key areas but particularly at the end nearest the footbridge. Extensive repair/construction works as well as significant realignment would be required to address this and this seems inappropriate given the adjacent quarry track. It may be more appropriate to block this section off entirely with hard landscaping and to reinstate the area with landscaping and planting.

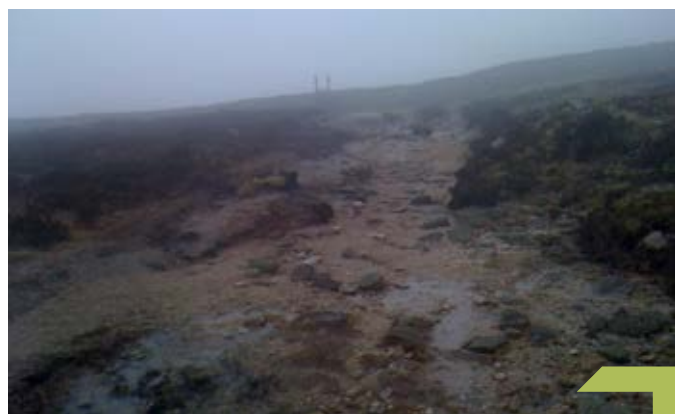
SECTION 2

This picture shows the path looking west towards the Mourne Wall – note that vegetation and peat has been removed over a wide area and that the substrate would appear to be being eroded by water on the left of the picture.

Braiding	Essentially this whole section is a heavily braided path across an area of up to 10m wide. There is essentially no single, clearly defined line.
Evidence of path repair	None
Associated features	Stile in wall
Trail Classification /Grading	Category 6 – due to variable surfaces, wet ground and level changes
General Observations and Recommendations	This section is very badly eroded and its visual impact is considerable. It is likely to worsen over time and impact on vegetation, soils and substrate is likely to accelerate. A much more clearly defined and robust path is required along this route, particularly given its popularity and importance. Any path works should centre on creating a more clearly defined path and significantly reducing its visual impact. Work should also include the reinstatement of the whole area that has been affected by the path. Any path works should ensure that the classification/grading of the path remains at Category 4 or above and its visual qualities should be appropriate given the location and the landscape.

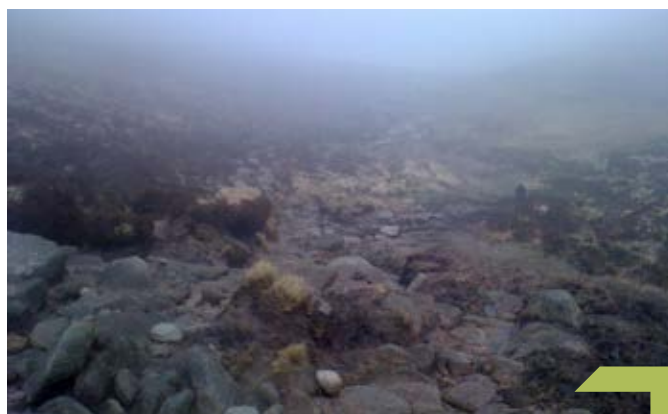
This picture shows the path a few meters further on – here again the vegetation and peat would appear to have been removed but the substrate is significantly more eroded.

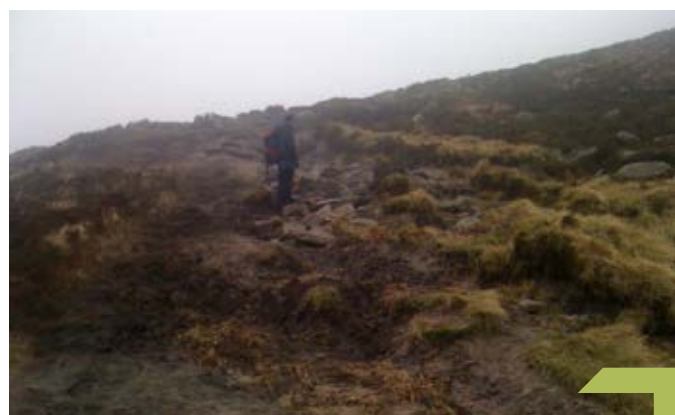
This picture shows a steeper section of the path where water has been having an effect on the vegetation, peat and substrate. Where the water has been flowing can be seen below the figure.

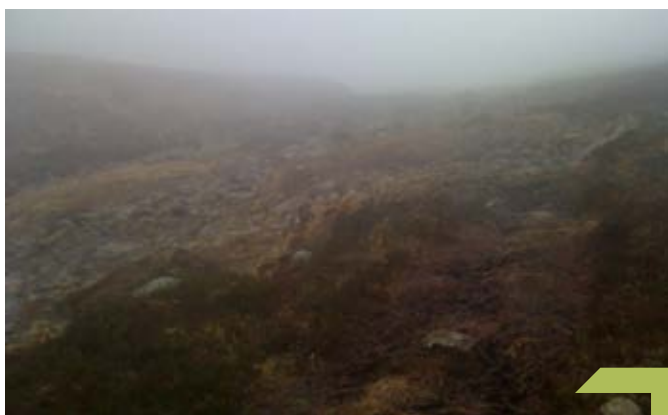
This picture shows the width of the impact of this path – in the left background can be seen an area of path which has been eroded down to the substrate and underlying boulders and glacial till, whilst in the foreground can be seen where braiding would appear to have resulted in the removal of ground cover vegetation and is also impacting upon the peat.

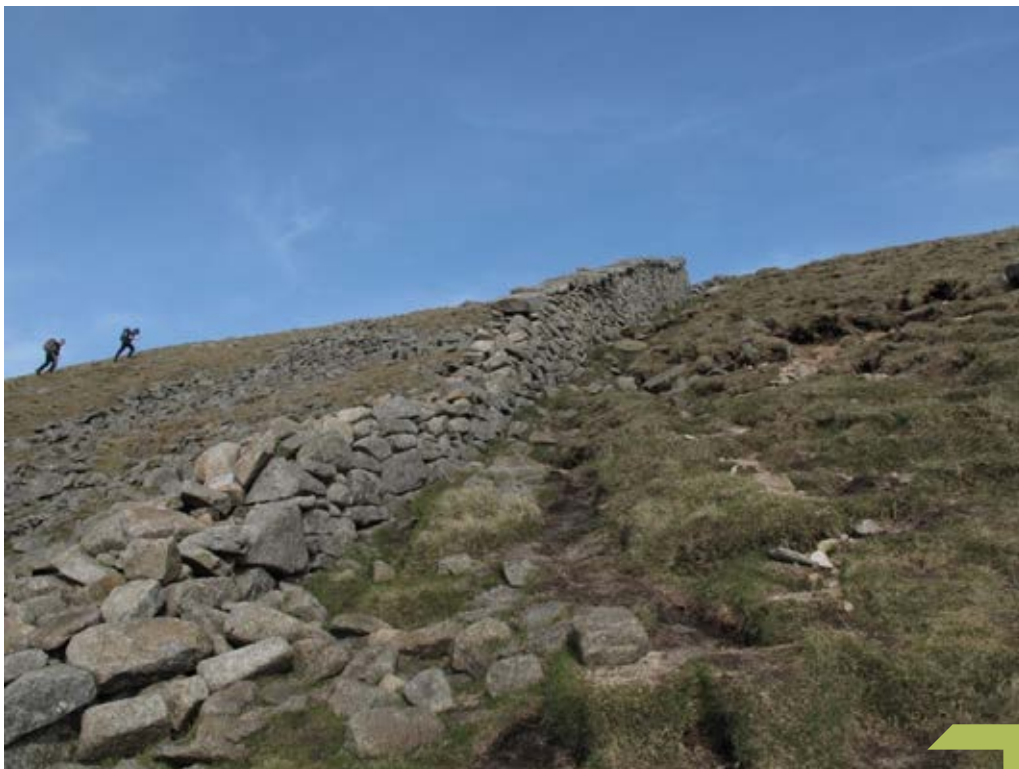
SECTION 3

This picture is typical of the kind of impact that this path has – note the ground cover vegetation which is potentially quite fragile

Braiding	Very heavily braided
Evidence of path repair	None
Associated features	This section follows the Mourne Wall throughout, which essentially defines the whole route
Trail Classification /Grading	Category 5/6
General Observations and Recommendations	<p>This section is potentially vulnerable to impacts because of steep side slopes and fragile vegetation cover. On both sides of the wall, walkers are using wide lines across potentially fragile ground. The presence of the wall forces people to walk on the fall line and the open slopes make it virtually impossible to contain walkers on one line. Braiding and erosion over an ever widening area is therefore likely to take place and possibly accelerate over time. However, it is felt that it would be inappropriate to carry out very extensive path construction in this case due to the visual and physical impacts this might have. Measures to reinstate and reinforce the integrity of the ground cover vegetation and therefore the stability of the slope should be investigated. These may include the seeding of affected areas with appropriate vegetation mixes and careful monitoring of impacts. However, these are likely to require ongoing inputs over a considerable period of time if they are to be successful.</p>

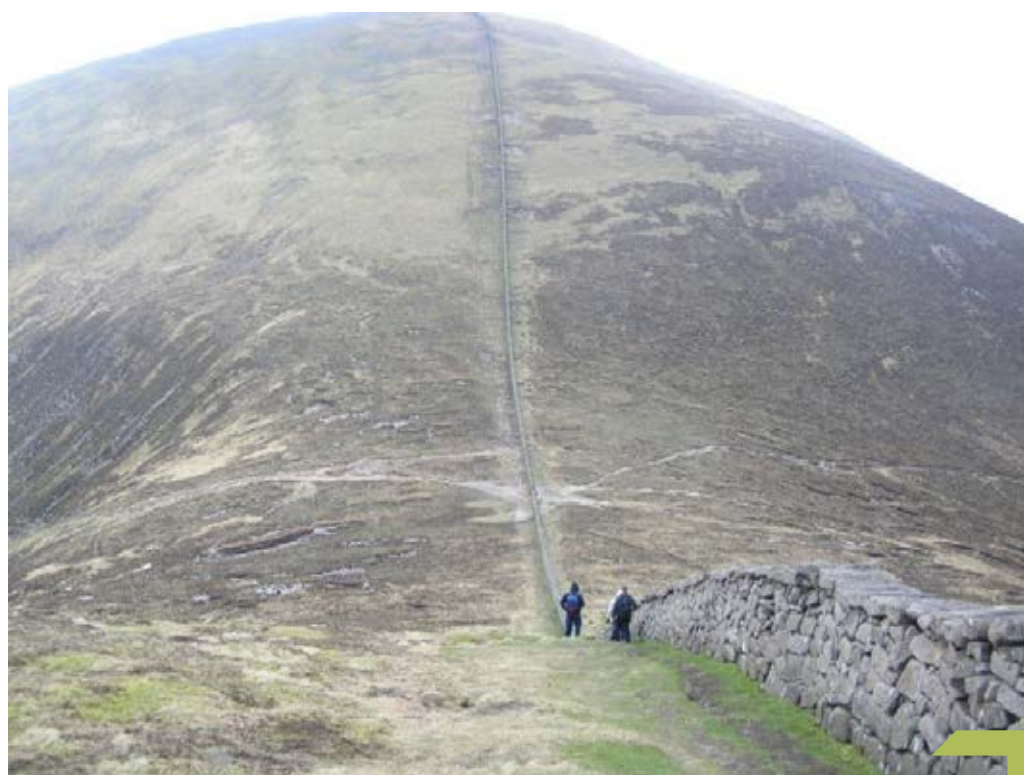
SECTION 4

This picture shows the path in question when viewed from Slieve Commedagh – note the path on both sides of the wall and the relatively wide footprint of the path on the ground. However erosion is currently confined to relatively small, isolated areas on particularly steep slopes.

Associated features	This section follows the Mourne Wall throughout which essentially defines the whole route
Trail Classification /Grading	Category 5/6 (due to steep gradients)
General Observations and Recommendations	On both sides of the wall walkers would appear to be using a seemingly widening line across what is potentially fragile ground. The presence of the wall forces people to walk on the fall line and the open slopes make it virtually impossible to contain walkers on one line, particularly when they are descending. Braiding and erosion over a widening area may therefore accelerate over time. However, it is felt that it would be inappropriate to carry out very extensive path construction in this case due to the visual and physical impacts this might have. Measures to reinstate and reinforce the integrity of the ground cover vegetation and therefore the stability of the slope should be investigated. These may include the seeding of affected areas with appropriate vegetation mixes and careful monitoring of impacts. However these are likely to require ongoing inputs over a considerable period of time if they are to be successful.

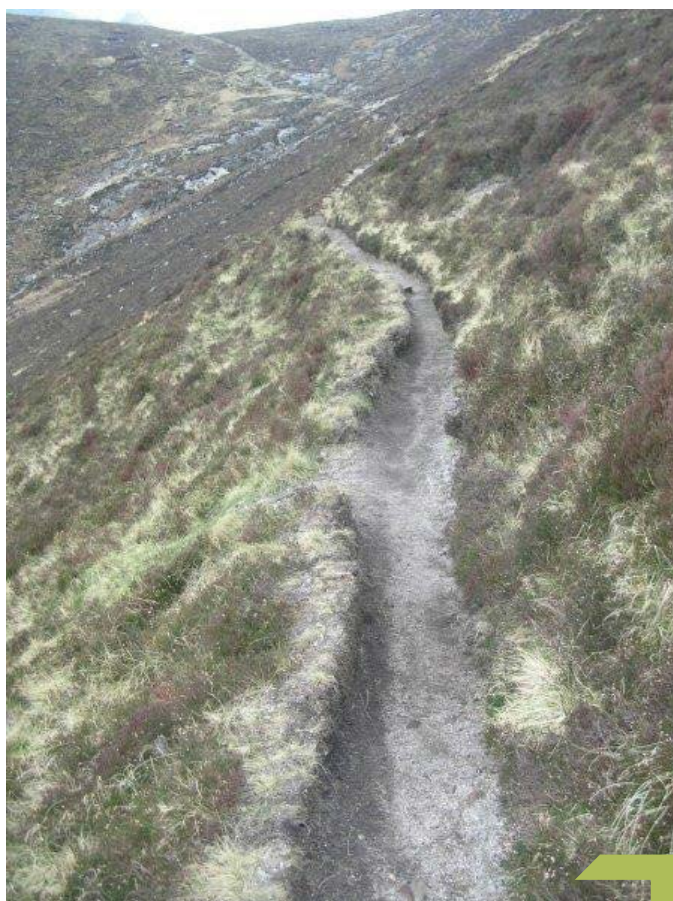
SECTION 5

The picture above show parts of this path where it is confined to one clearly defined and narrow line. In these areas the visual impact of the path is minimal and it would seem to be able to withstand the volume of use it receives.

Path surface	Extremely variable, including compacted gravel and earth, mud, scree, stone pitching, rocks and boulders
Width	600mm – 3m
Evidence of erosion	Very extensive erosion at key locations, particularly on sections of over 30% gradient
Braiding	Extensive braiding at key locations, particularly on slopes of more than 30% or where there is erosion
Evidence of path repair	Extensive repair works including revetments, stone pitching and benching
Associated features	None
Trail Classification /Grading	Category 4/5
General Observations and Recommendations	<p>Where the gradient of this trail is less than 50% of the gradient of the slope, or where it is effectively demarcated by steep side slopes, it is generally in good condition with only minor braiding and erosion and is also extremely robust. However, erosion and braiding is extensive in key areas and the visual impact of this path is quite significant where this is the case. Any path works should focus on reducing visual and physical impacts whilst retaining the integrity of the "mountain experience" and not increasing the accessibility of the path.</p> <p>This may require minor realignments at key locations and also considerable remediation/ reinstatement of vegetation where erosion has been significant. However, it is also very important to ensure that the path is not made more accessible by reducing its visual and physical impact. This will require careful design work as well as the development of very prescriptive plans which are centred on working in low impact sustainable ways.</p>

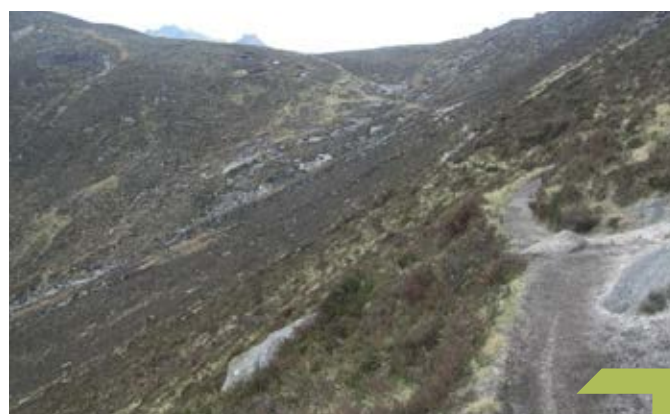
This picture illustrates the low level of impact that this path has where it is on the contour and in effect demarcated by steep slopes.

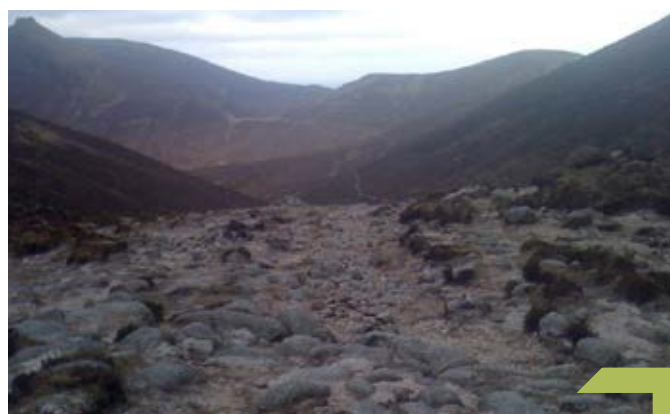
This picture shows a section of the brandy pad where visual and physical impacts are considerably greater than those that are shown above. Note the removal of ground cover vegetation exposing the underlying substrate. This is also beginning to show signs of erosion.

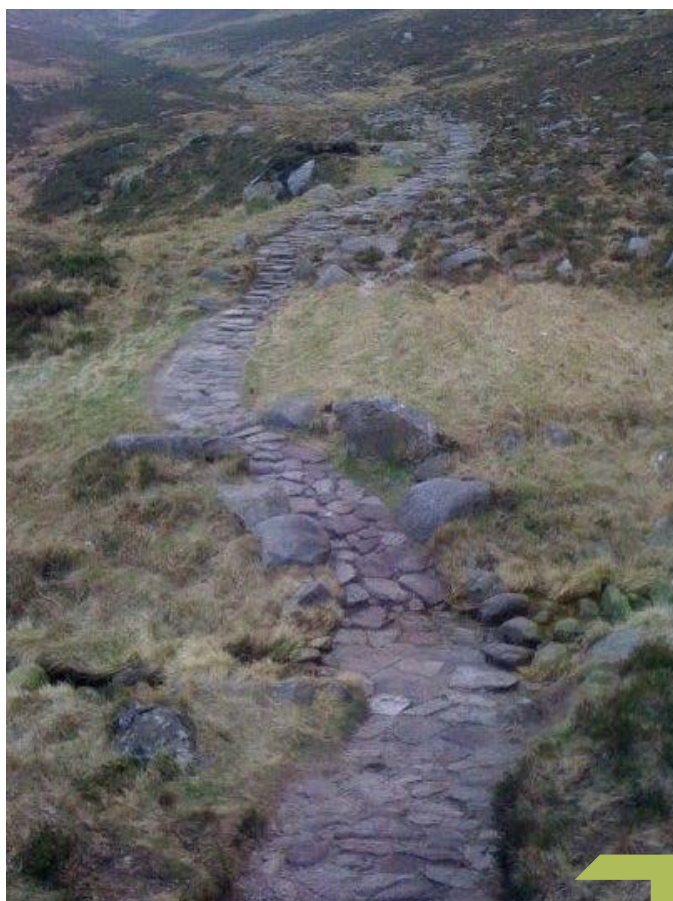
SECTION 15

This picture shows a section of very high quality stone pitching on this path which has been very successful in addressing the visual and physical impacts of the path overall. However, some critical maintenance is required to ensure that the stone pitching continues to manage the impacts of walkers.

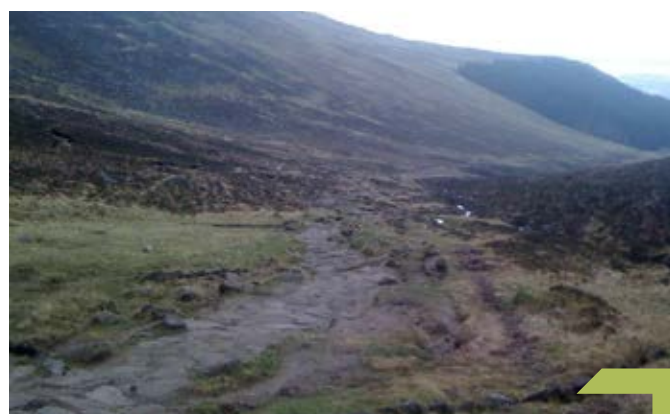
The above picture shows braiding taking place adjacent to a stone pitched section. This should be addressed by effective landscaped demarcation

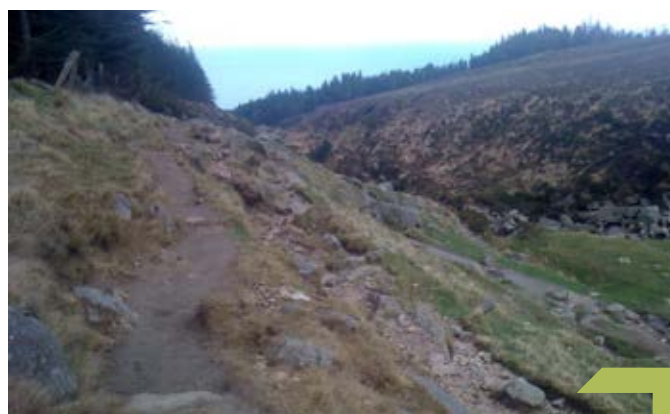
The above picture shows ongoing works to reduce visual and physical impacts of this path by establishing a more clearly defined and robust single line and blocking off other routes. The braiding of the path can clearly be seen in this picture with at least three lines in evidence.

Evidence of path repair	Very extensive and high quality stone pitching in upper half. Ongoing works to lower section.
Associated features	Stile in wall at col of Donard
Trail Classification /Grading	Category 5 due to gradient and large level changes
General Observations and Recommendations	The stone pitching in the upper half of this section has been largely successful but additional demarcation is required to prevent braiding. Works are ongoing to reduce the visual and physical impacts of the lower section. This path is one of the most important in the Mourne and as such is likely to be under constant and increasing pressure from users. Path repair works should centre on reducing the path's visual and physical impact and not to make it more accessible.

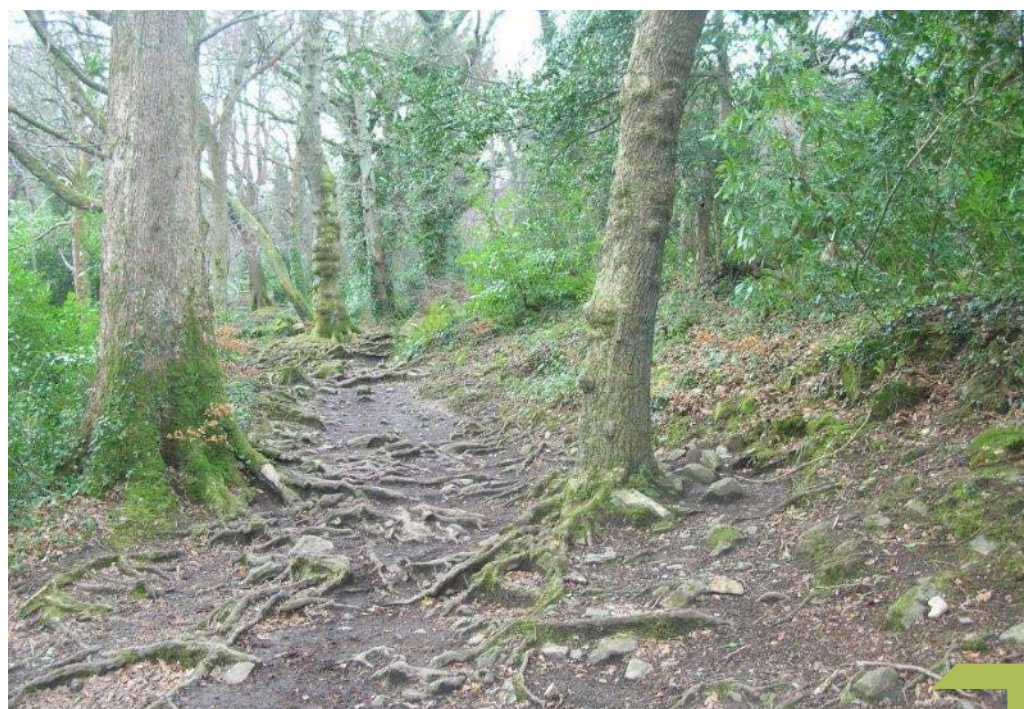
SECTION 16

The above picture shows typical conditions found on this path i.e., exposed roots and compacted gravel. The impact of this path would appear to be acceptable, however, the quality of the surface is one of the factors leading to the development of numerous desire lines.

Braiding	Quite extensive throughout with numerous lines at key locations. Braiding would appear to occur mostly where path is not constricted by vegetation.
Evidence of path repair	Some historical water bars and path construction Current repairs underway from third bridge
Associated features	Stone steps in poor condition
Trail Classification /Grading	Category 4/5
General Observations and Recommendations	This path is extremely heavily used by a wide range of users and its condition is, in places, leading to the development of desire lines to avoid difficult, slippery or uneven surfaces. Desire lines should be addressed by appropriate demarcation techniques and eroding areas should be addressed. However the overall classification/grading of this path should remain at around Category 4/5 and access to it should not be made easier.

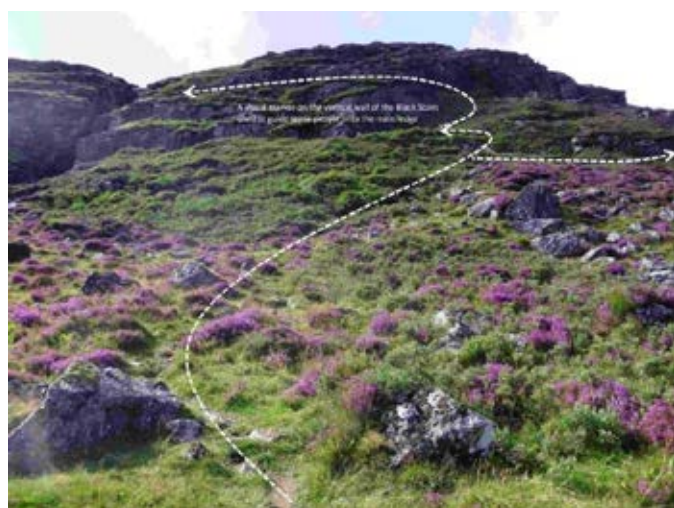
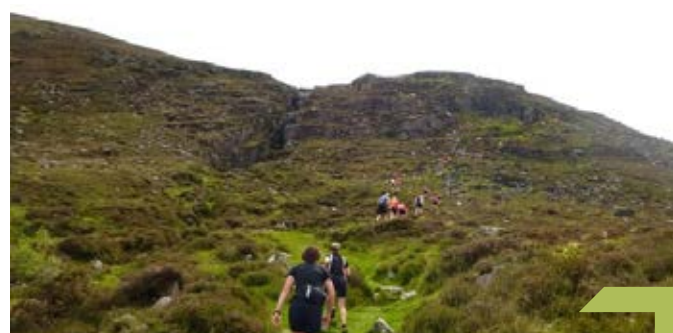
SECTION 16A

The Black stairs is a popular route with Hill and Dale events but has to navigate a steep outcrop. Erosion is localised and there are some signs of recovery in places, but the route could be vulnerable to increased use.

Evidence of erosion	Erosion apparent at bottleneck area of black stairs. Occasional but not frequent above that. Although there is observational evidence of a recovery from erosion on the wider sections of trail line above the black stairs – the profile of the trail line is sunk into the landscape suggesting a loss of vegetation and peat.
Braiding	Not a feature
Evidence of path repair	No
Associated features	Black stairs tricky to navigate through during winter as it's a seepage area that gets iced up
Trail Classification /Grading	Category 6 – for the actual black stairs; the rest is category 5
General Observations and Recommendations	<p>Used mainly by users going up Donard (up-traffic)</p> <p>Erosion and accessibility should be monitored, especially before and after events, which have a greater negative impact than casual users</p> <p>There may be a knock-on effect from the Mourne Gateway proposal in terms of future use and the impacts of that</p>

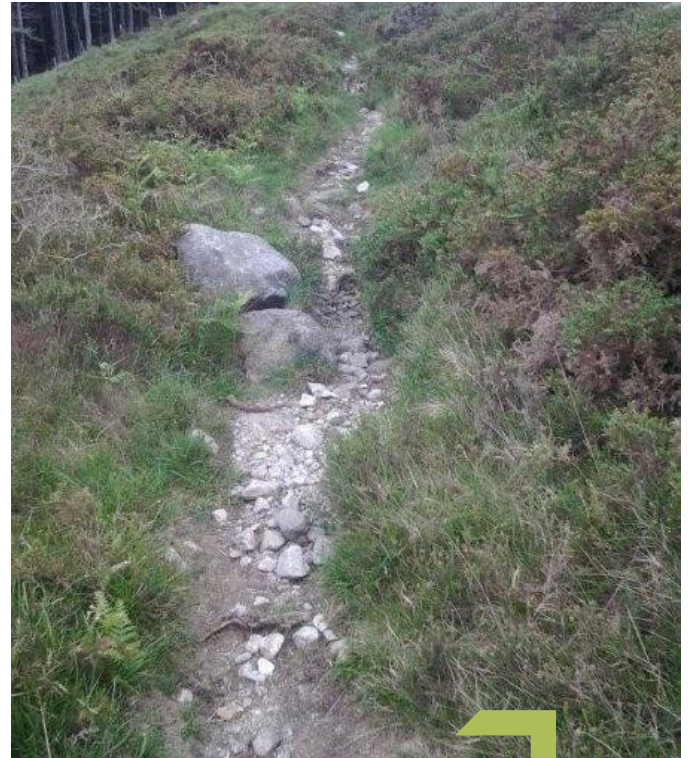
Link from Granite trail bogey line to Drineever

General Observations and Recommendations	<p>Wet weather survey (WWS) and subsequent drainage work needed on southern half of trail – 920m section and 430m section.</p> <p>Will be impacted heavily if Mourne Gateway Project is realised.</p> <p>The priority work needed on the Granite trail has been identified and discussed with the council.</p>

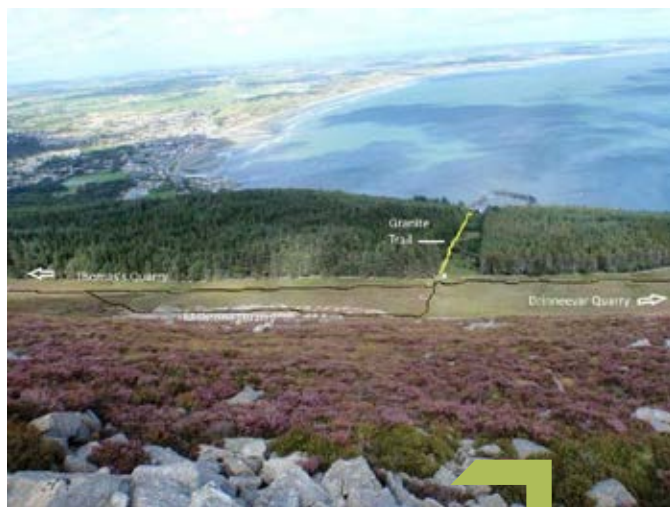
Three Quarries looking down from Millstone

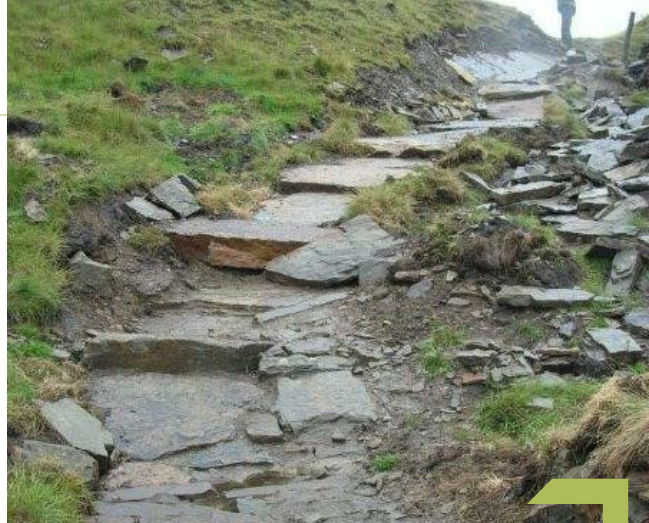
The above picture shows a formally built Category 4 upland trail with numerous level changes of up to 400mm high

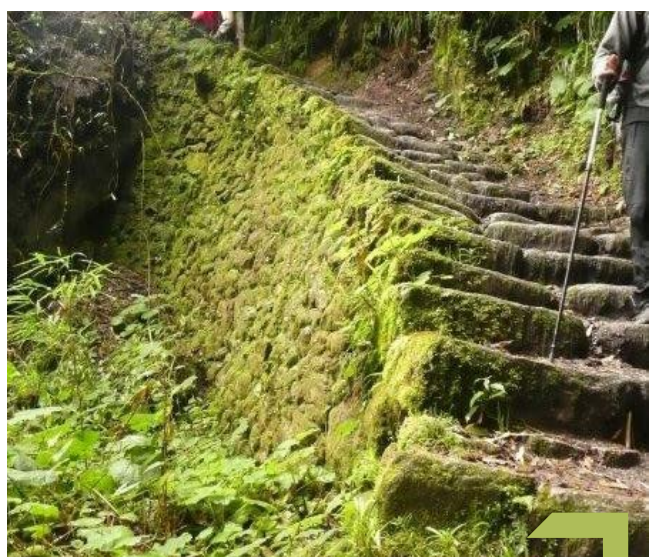
This picture shows stone steps on a Category 6 trail. Note the steep gradient, high frequency of the steps and the short length of the treads, also note the unprotected edge or drop of more than 2.5m

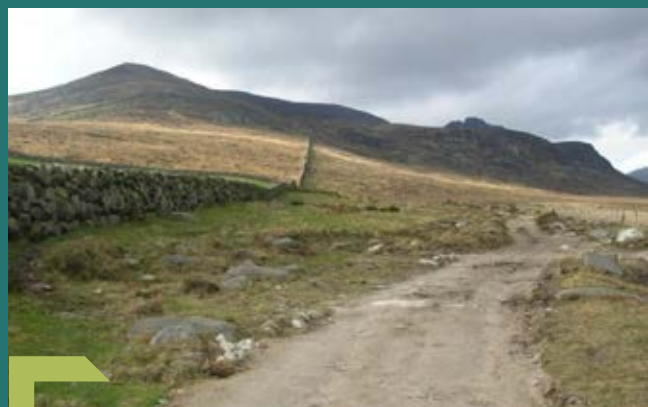
The above picture shows a Category 1 trail which is also a vehicle access track – note the largely compacted and even surface, width (2.5m) and low gradient (around 6%)

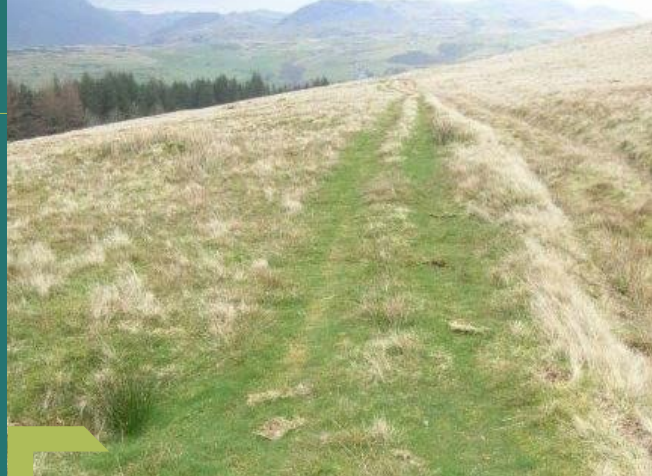
The above shows a Category 1 trail with a surface of short ground cover vegetation – note the low gradient and 2m width

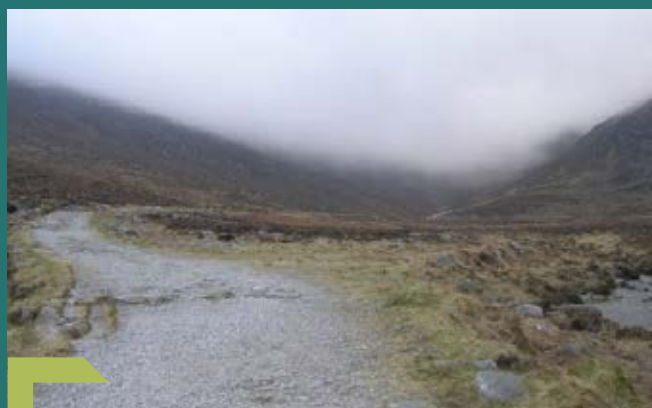
The above picture shows a Category 1 trail which is also a hardened and compacted vehicle track – note the width, small level changes and low gradient

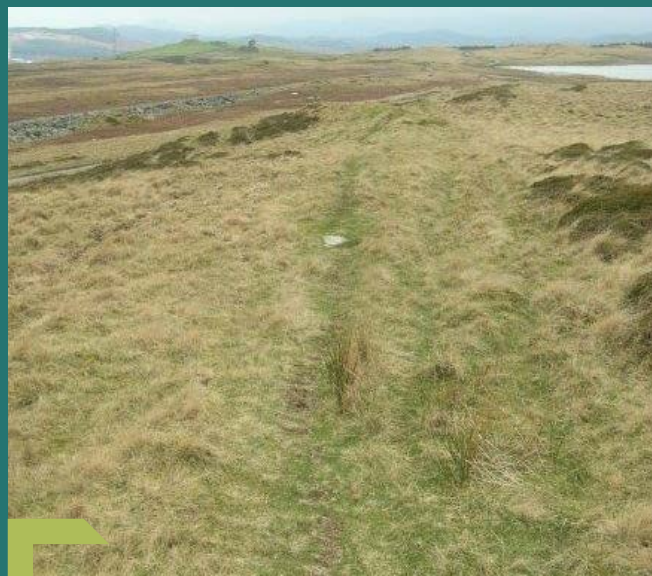
The above picture shows a Category 1 trail with no formal built structure. It is in fact little more than a well established livestock or animal track – note the low gradient and surface of close cropped compacted vegetation. It should also be noted that the surface is both dry and stable.

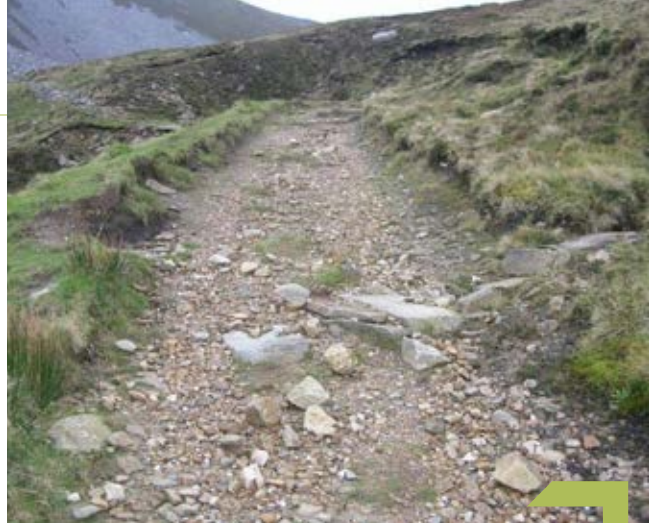
The above picture shows a Category 2 upland trail which has no formal built structure, but has become established over time – note the 2m width, loose surface and small level changes

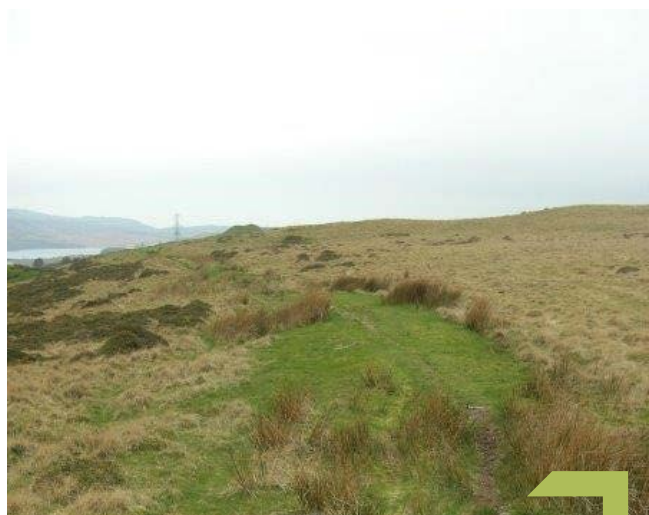
The above picture shows a Category 2 trail with only a partly constructed underlying structure – note the variable surface which includes some loose material, mud and vegetation.

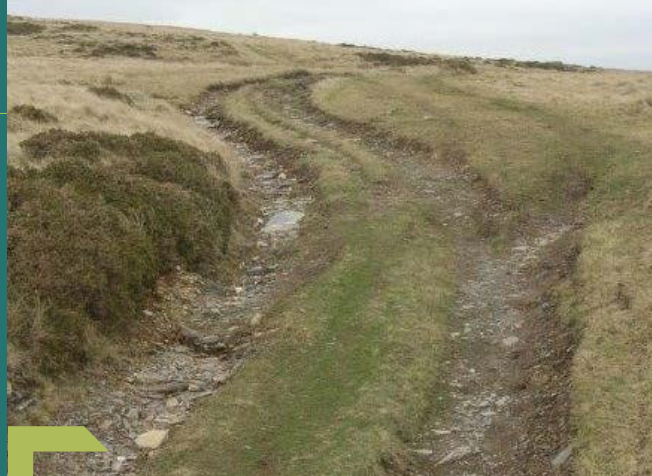
The above picture shows a Category 3 vehicle track – note the width (2m), gradient (6%) and variable surface.

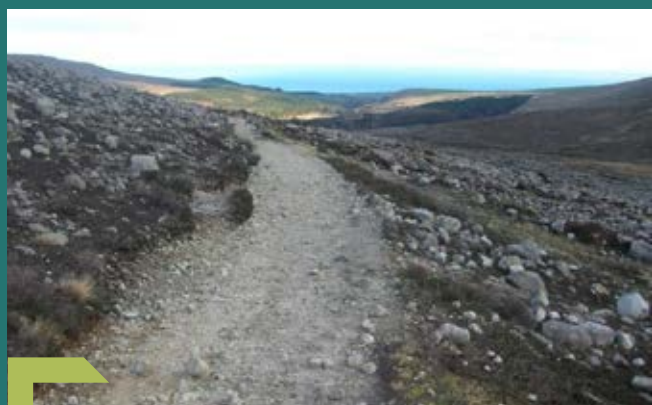
The above picture shows a purpose built Category 3 trail – note the width (1.5m) and the uneven surface

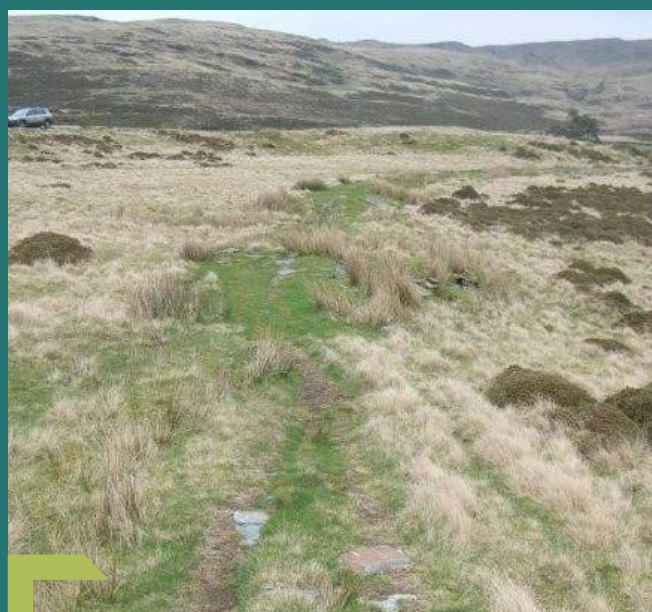
The above picture shows a Category 3 trail with little or no underlying structure – note the width, slightly uneven and variable surface which includes stones, soil, mud and grass. Also note the low gradient which qualifies this trail as Category 3 even when taking into account the nature of the surface.

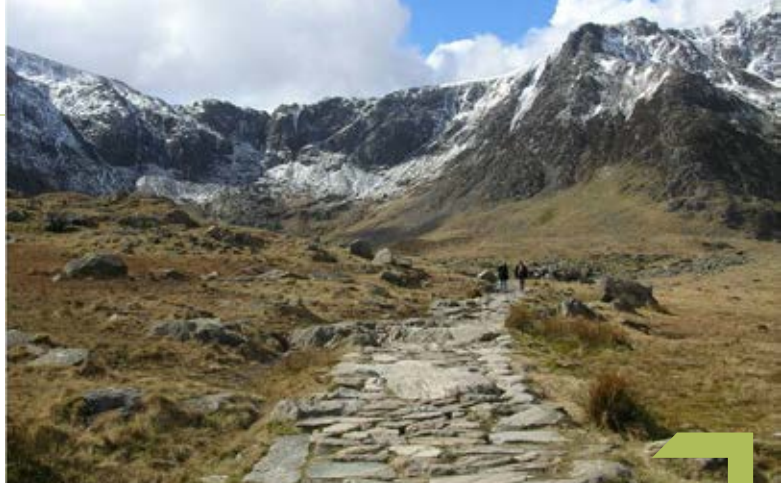
The above picture shows a Category 4 trail – note the uneven surface, level changes but low gradient. Whilst the gradient is low (5%) the uneven surface and size of the level changes qualifies this trail as Category 4.

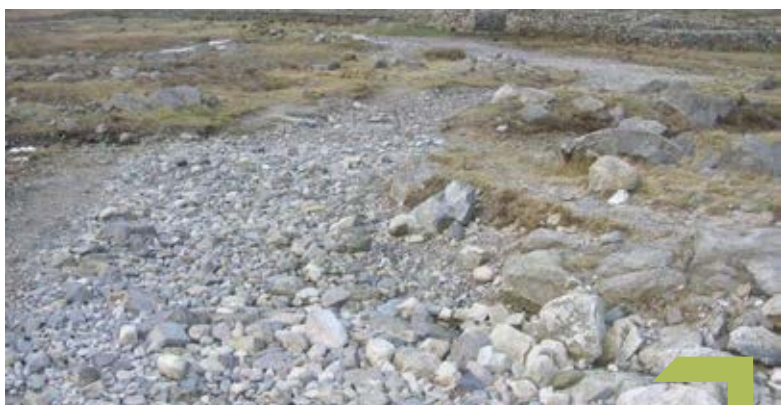
The above picture shows a Category 4 trail that is also a vehicle track – note the unstable surface made up of large loose material and steep gradient (18%)

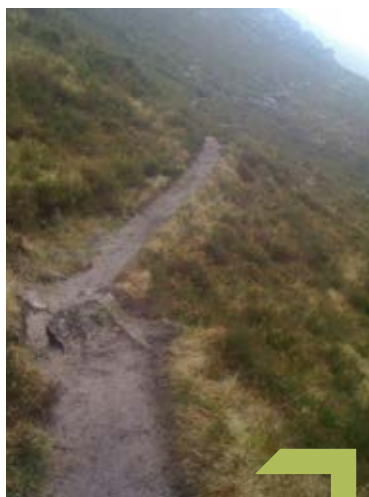
The above picture shows a Category 4 trail with no formal built structure – note the very narrow tread (600mm) and level change (200mm)

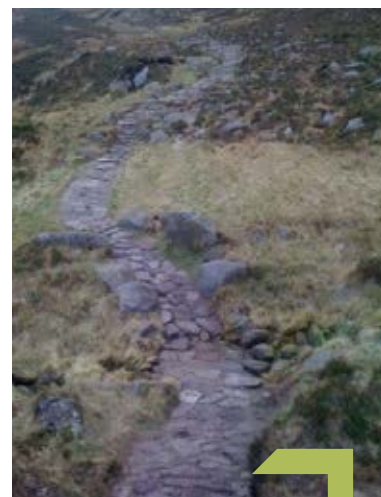
The above picture shows a purpose built Category 4 trail featuring extensive stone pitching – note the width (1.2m maximum), uneven surface with small level changes. Also note the average gradient (around 15%)

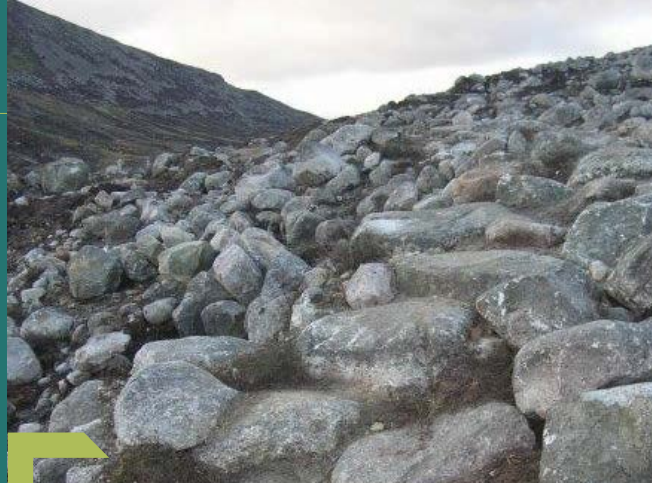
The above picture shows a Category 5 trail – note very uneven surface, numerous and very frequent levels changes

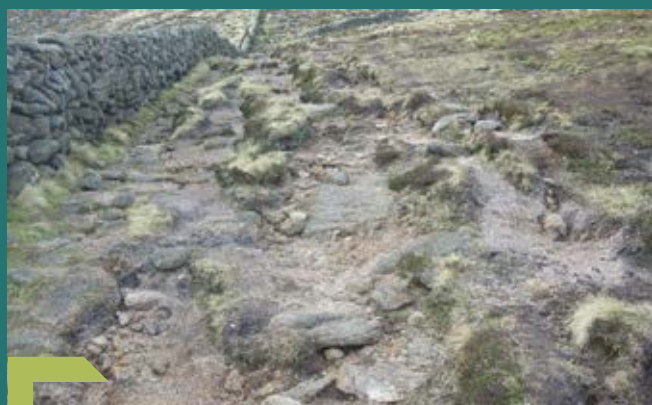
The above picture shows a Category 5 trail which has no formally built underlying structure and is essentially a desire line – note the steep gradient (20%), numerous level changes, gullies and large loose material

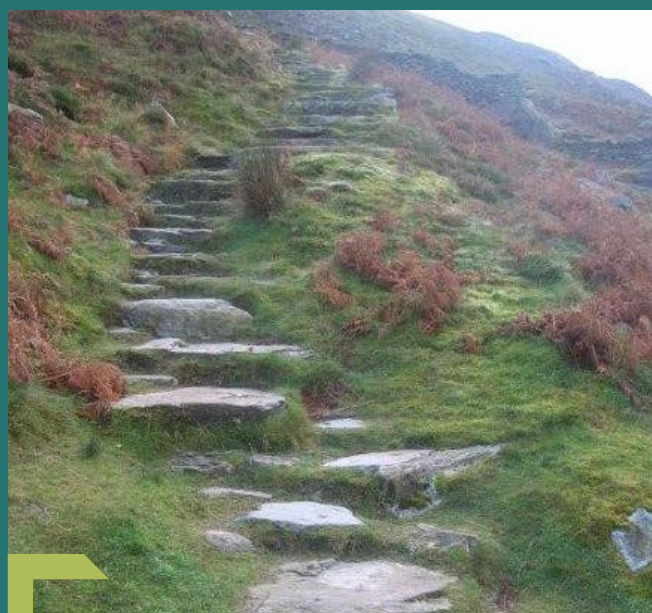
The above picture shows a Category 5 trail – note the steep gradient, very uneven surface, numerous level changes and narrow width

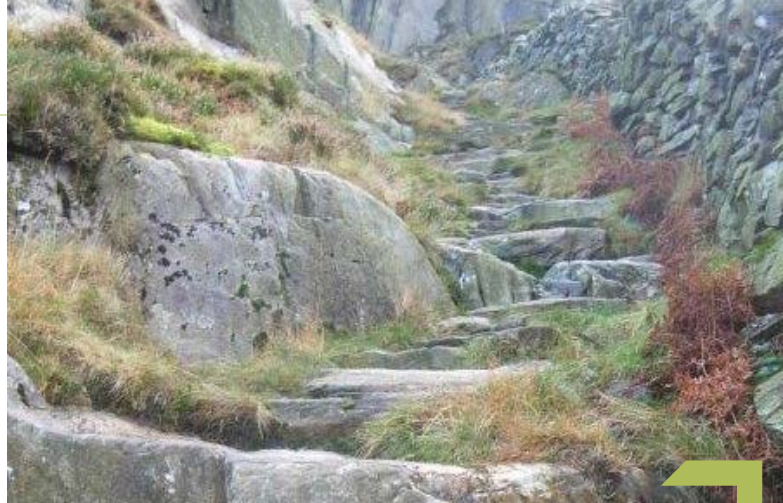
The above picture shows a formally built Category 6 trail – note the steep trail gradient (35%) and large level changes (up to 800mm)

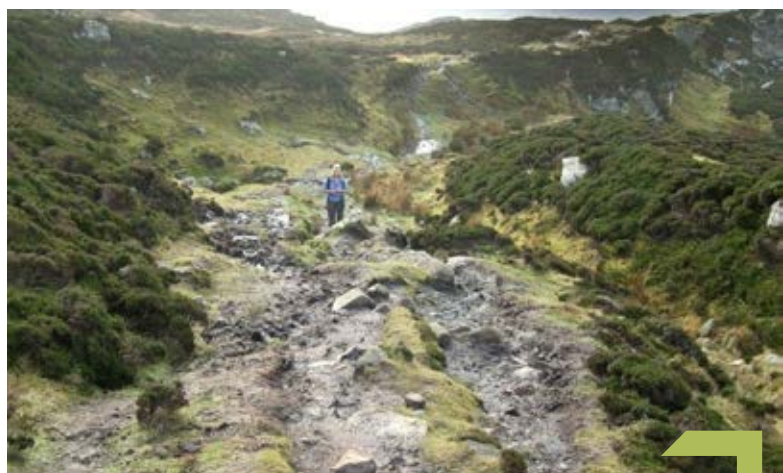
The above picture shows a Category 6 trail with no underlying formal structure and which is essentially a desire line – note the steep gradient (35%), very uneven, loose and slippery surfaces, including boulders and mud and the numerous lines on the ground.

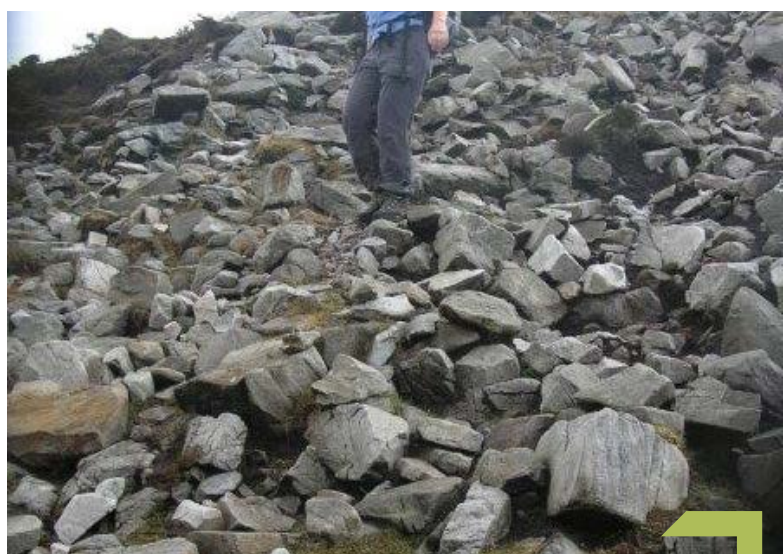
The above picture shows a Category 6 trail with no formal underlying built structure. This is essentially a desire line through scree and the surface of the trail is unstable, uneven and loose. The line of the trail is not immediately apparent.
