Hiding Old Traces

PIENI KARHUNKIERROS
HIKING PATH

OULANKA NATIONAL
PARK

Applying new solutions in path management for safety and habitat protection

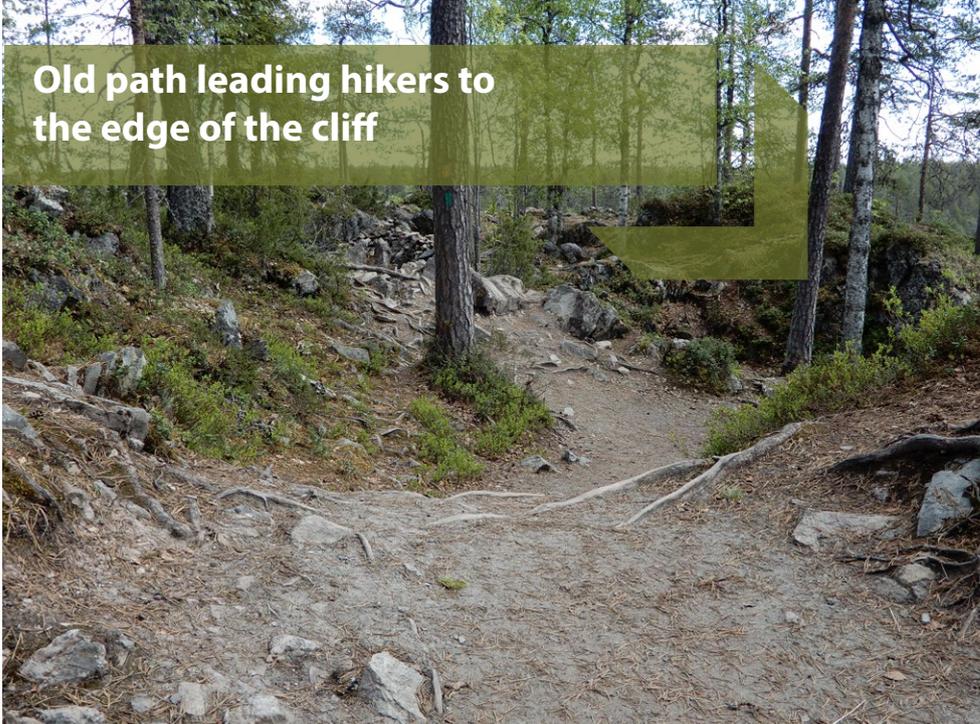
Old path leading hikers to the edge of the cliff

A new implementation plan was made for Pieni Karhunkierros Hiking Path in the Oulanka National Park, Hossa region. The path is 12 km long, and the plan included many construction and path building sites. As part of the plan, the old path was diverted away from a dangerous cliff edge. Hikers tended to follow the old path, and beyond, to have a look down at the river canyon at a scenic point. There were no railings or ropes to secure visitors in any way; the cliff edge in question was not a designated scenic point. Further to safety issues, erosion caused by hikers threatened endangered flora growing on the cliff.

As the rocky habitat, and flora depending on it, is very scarce in the area, it was felt important to protect it from getting more eroded than it already was. The old path also led to a long flight of stairs that was in a poor shape and in need of repair. Instead of replacing the stairs, the aim was that hikers would use the new path through a safer terrain straight into a newly built view point. With the stairs gone, it was no longer possible to continue on the old path.

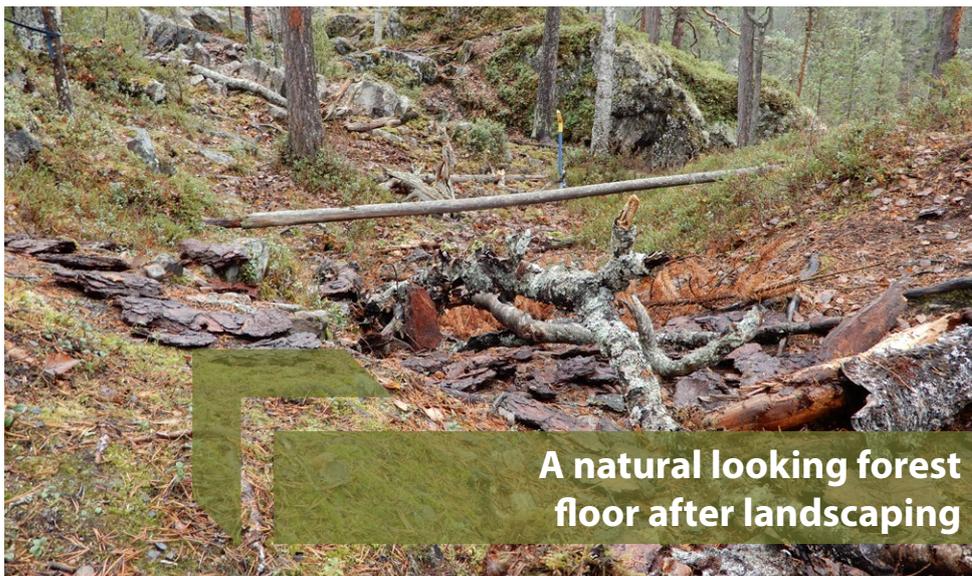
A natural looking forest floor after landscaping

visitors and to stop further erosion. Pieni Karhunkierros is situated in a forested area and materials needed to be collected from nearby. Pieces of rotten wood, leaves and moss were taken from the surroundings in such a way that it wouldn't disturb the landscape or threaten the flora. A barrier made with tree trunks was built to make the old path uninviting and to block passage to the cliff edge.

Landscaping of the old path on Pieni Karhunkierros was a fairly straightforward exercise. The area that needed to be camouflaged was not big and materials were abundant in the vicinity of the site. Collecting material in an environmentally friendly way posed some challenges. It was important that this activity would not disturb the surrounding nature in any way and would not leave visible marks on the terrain. This activity shows that even a relatively small effort can make all the difference. Diverting visitors from using the old path and blocking access to the cliff edge is vital for the protection of habitat and flora, but it also protects visitors from a dangerous edge on a high cliff.
