Fixing the path 'root and branch'

GLEN RIVER PATH

SLIEVE DONARD

Piloting a natural and sensitive way of protecting trees while maintaining a popular mountain access route to Slieve Donard

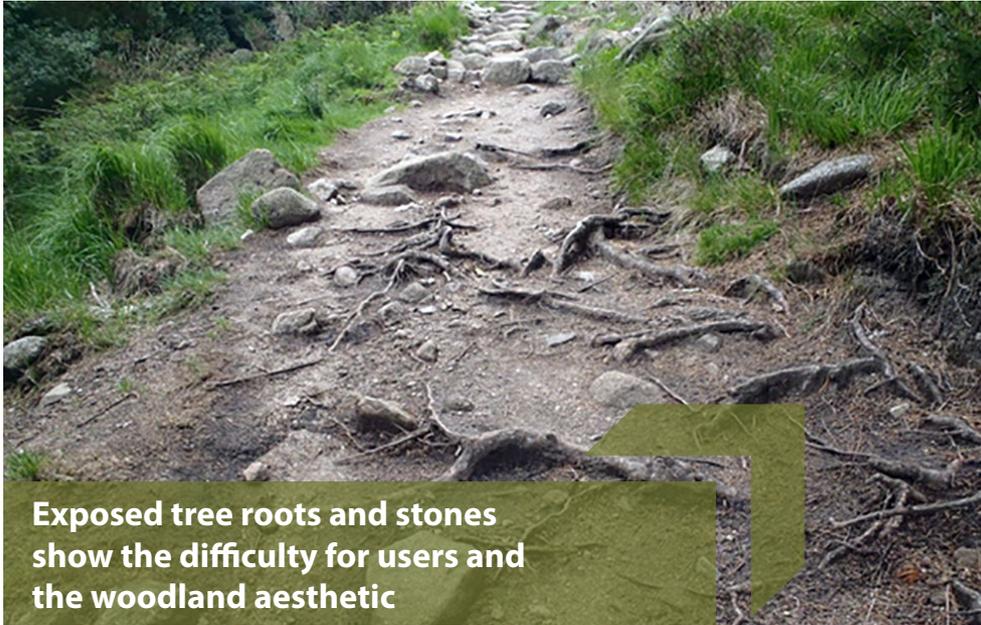
Exposed tree roots and stones show the difficulty for users and the woodland aesthetic

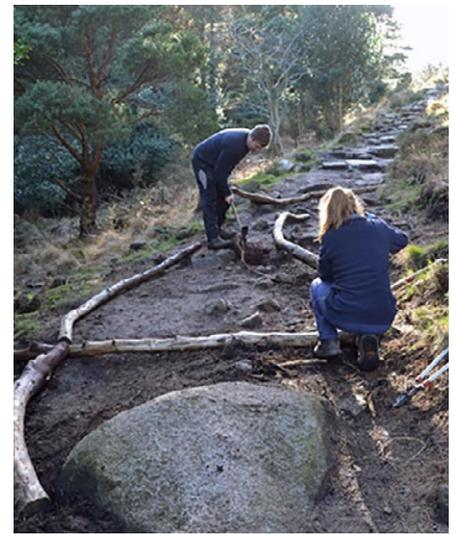
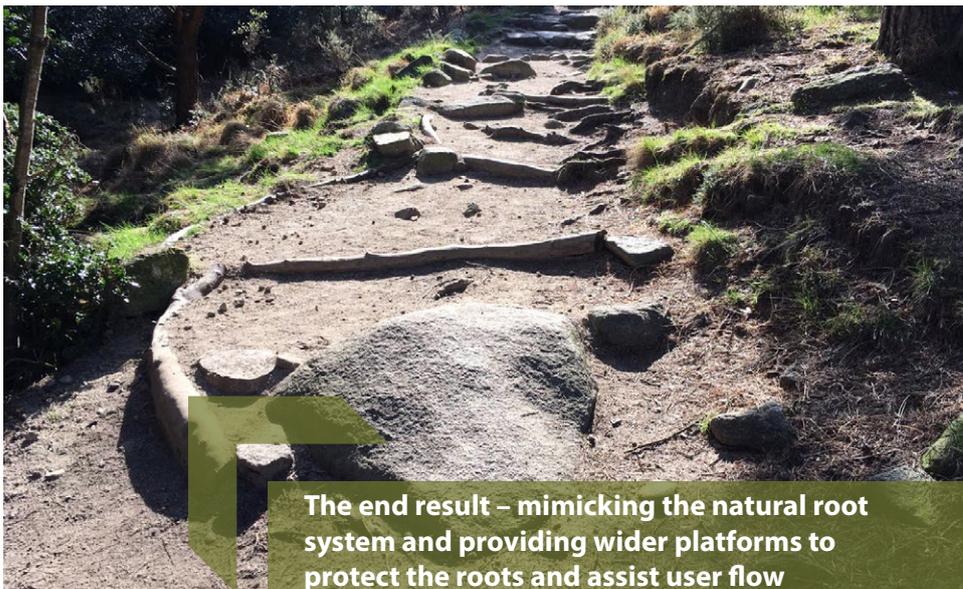
The end result – mimicking the natural root system and providing wider platforms to protect the roots and assist user flow

Scots pine branches were chosen due to their hardness, selecting those with natural curves, which both mimicked root curves and gave a good retaining capture of the aggregate. The branches were larger than the roots in order to provide sufficient retaining quality and were stripped off their bark, dried and treated with preservative before installation. They were placed carefully on top of the exposed roots providing larger platforms or steps than the actual roots would allow, and were secured by use of wooden/metal pins. Locally won aggregate (mineral soil) was backfilled behind the branches and tamped down. The ASCENT Path Team were assisted by the Mourne Heritage Trust Volunteer Path Team early in 2018; repairing approximately a 25 x 1 metre path section in this way.
