# Solving water erosion in practise

GRYTESKAR PASS

## Trialling techniques for draining water from the path at Gryteskar pass: ASCENT teams from Trolltunga and Mournes

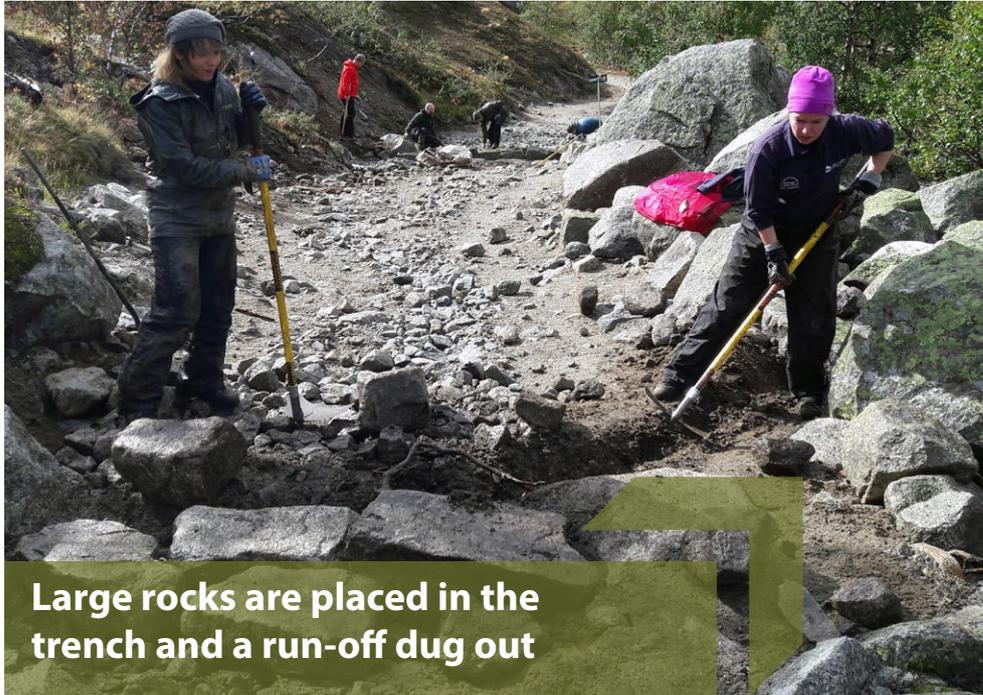
Large rocks are placed in the trench and a run-off dug out

1. The French drain was constructed by digging trench diagonally across the path, which was filled with larger rocks sourced from the sides of the path. Care was taken to leave sufficient gaps to allow water to flow through the rocks. A run-off was created at the lower end, leading into the ditch.
2. To construct the cross-drain, a trench was dug diagonally across the path, then lined with larger, rectangular flat stones. Several levels were created using larger stones to form natural "pools", also functioning as stepping stones across the open drain. The levels, combined with a layer of gravel and aggregate, help slow the water speed to prevent erosion to the side of the path.

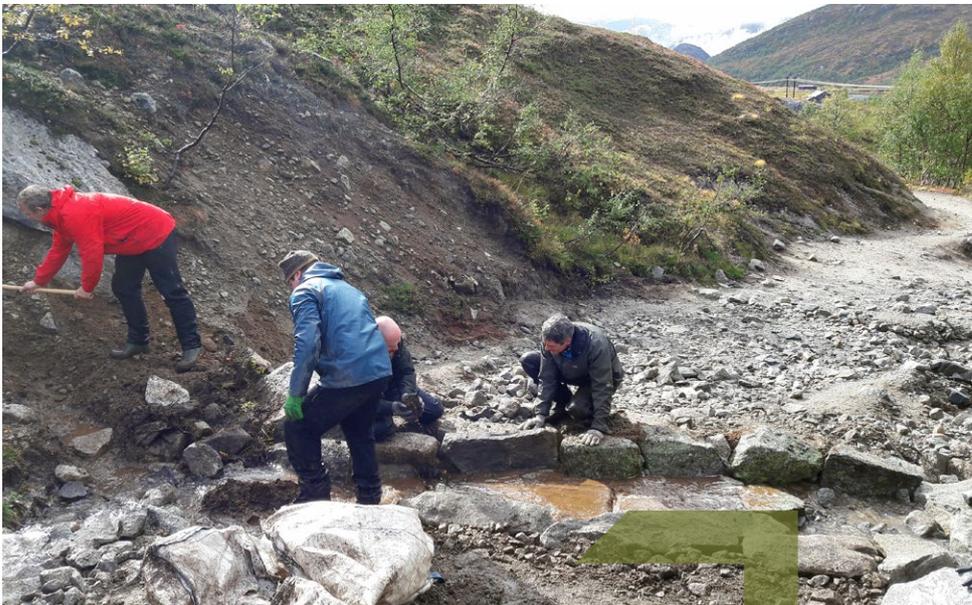
**The new drain is almost complete. Notice erosion to the road.**
