The importance of knowledge exchange

SKÓGAHEIÐI

ICELAND

A reactive response to a problem can often cause a different problem at a different and unforeseen place

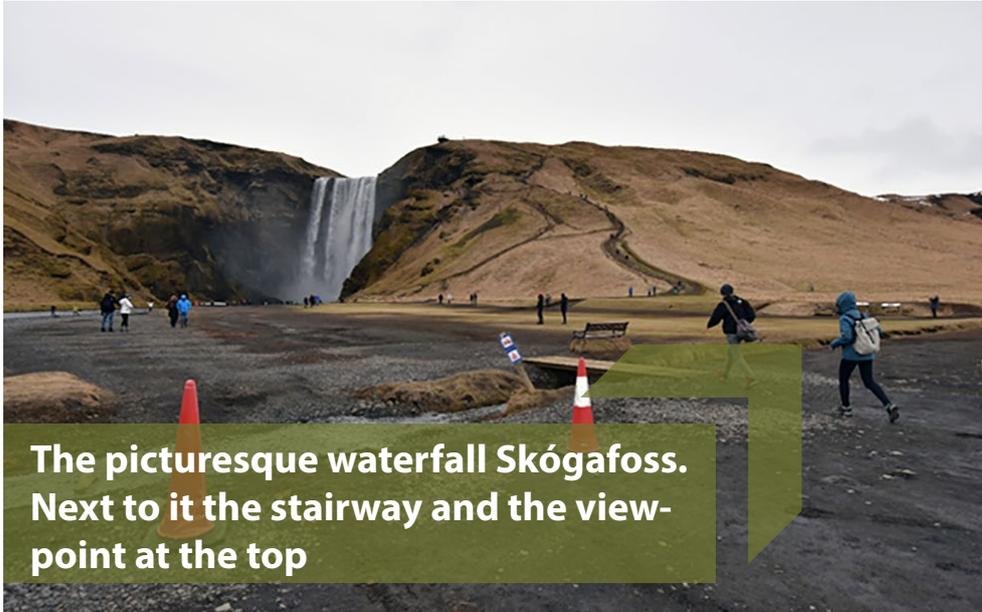
The picturesque waterfall Skógafoss. Next to it the stairway and the view-point at the top

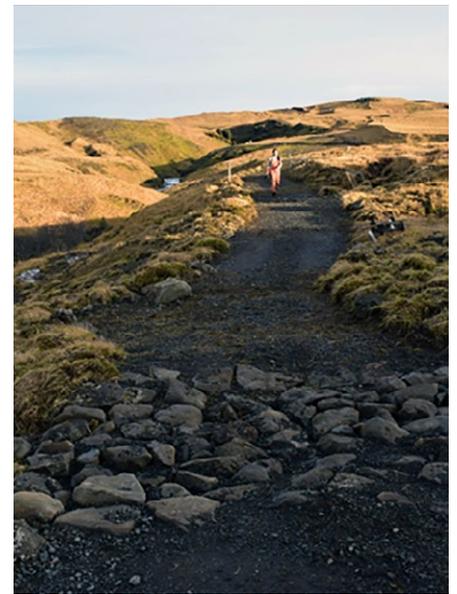
The approach was taken to try and reduce the number of water sources above the path, gather them in fewer channels, and divert them into fewer drains crossing the path. Then to build up the margins of the path with turf but at the same time making water find a way out at the lower edges so that it couldn't form a stream down the path and sweep away the surface layer. Turf was also used for habitat restoration as well as seed cuttings found beside the path. The whole project was based on the local material use and traditional style of handwork.

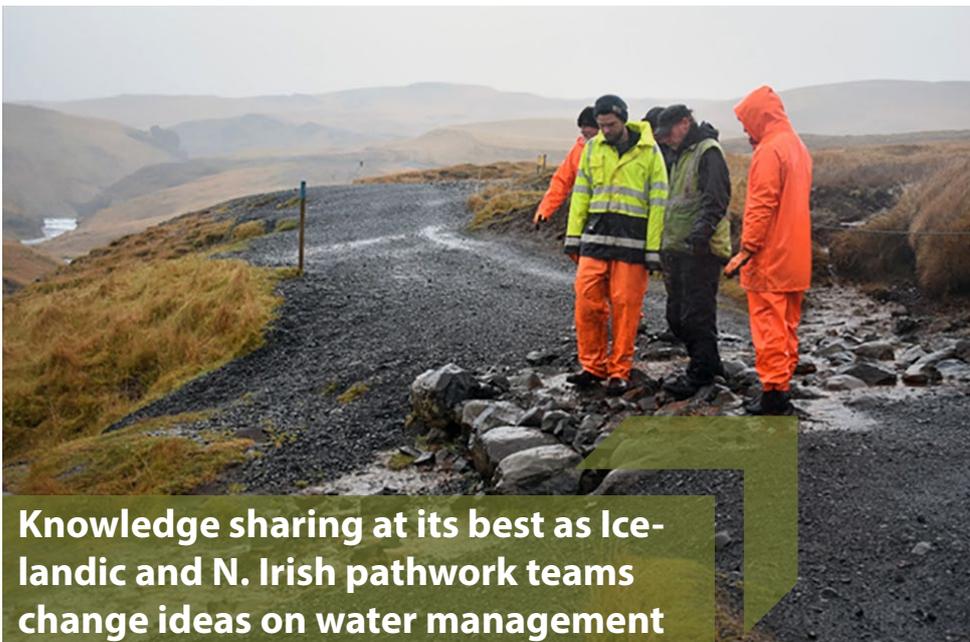
Knowledge sharing at its best as Icelandic and N. Irish pathwork teams change ideas on water management
